HISTORIC STRUCTURE REPORT

LAWNFIELD
HISTORIC STRUCTURE REPORT
JAMES A. GARFIELD NATIONAL HISTORIC SITE

Prepared by
Paul Newman

DENVER SERVICE CENTER
NATIONAL PARK SERVICE
UNITED STATES DEPARTMENT OF THE INTERIOR
DENVER, COLORADO

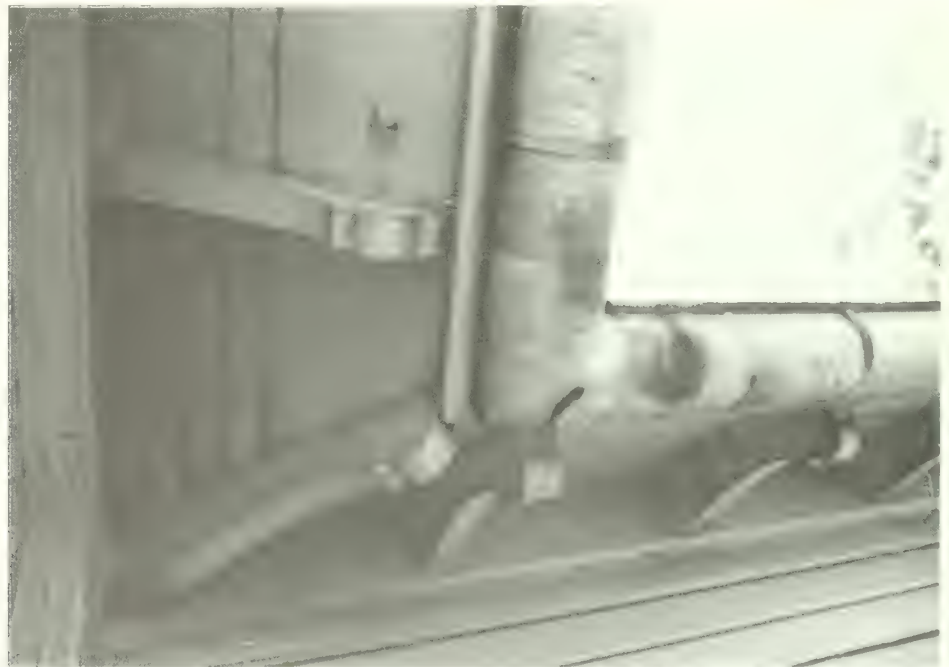
CP-15, Eave detail at the downspout. The hole through the roof sheathing at the right is from original downspout. Half-round gutter at the left has replaced the original trough gutter system. Pigeons on the bracket soil the building with waste.

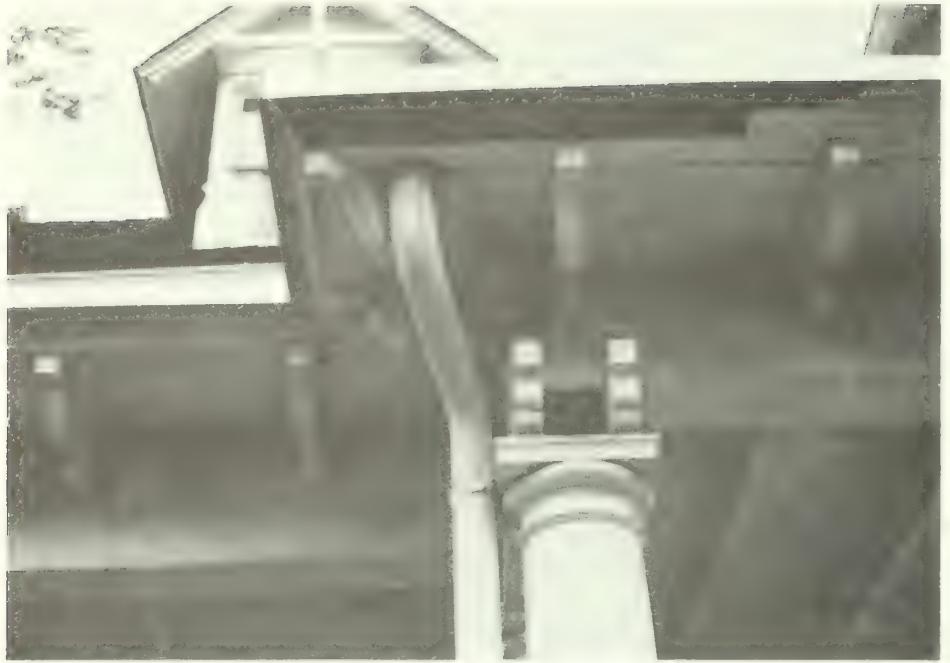
CP-18, Deteriorated roofing of the east porch.

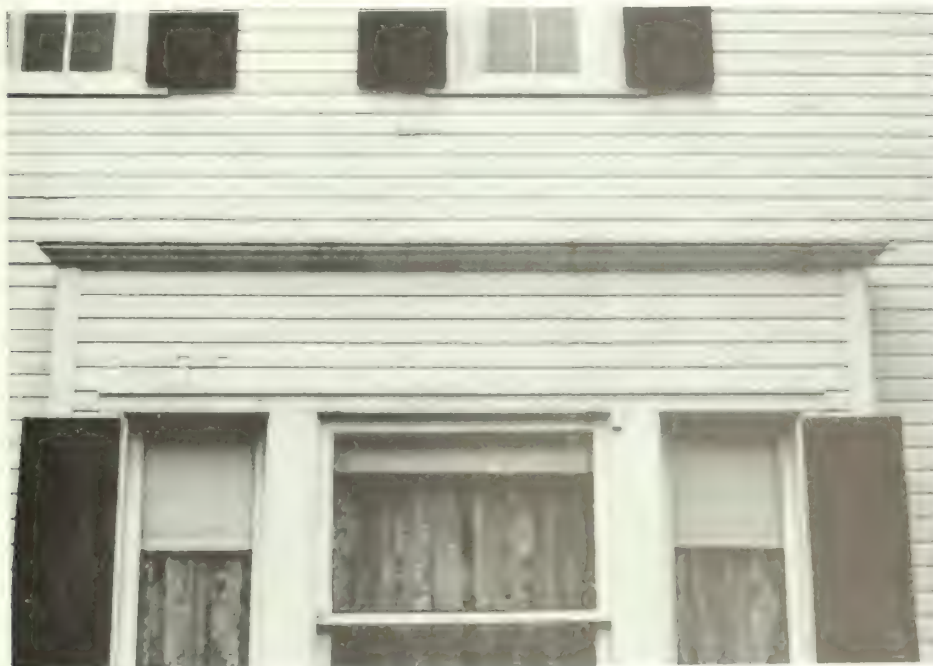
CP-21, 1904 bay window replace the original windows and door to the sitting room. Joist pockets of removed arbor are visible above the side windows.

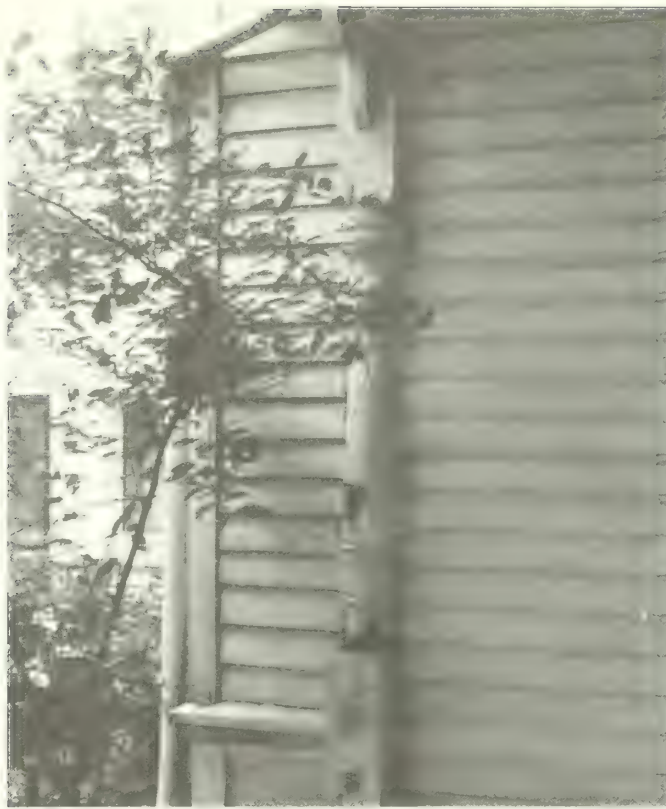
CP-34, West porch, shadow of original porch brackets is visible below the replacement.

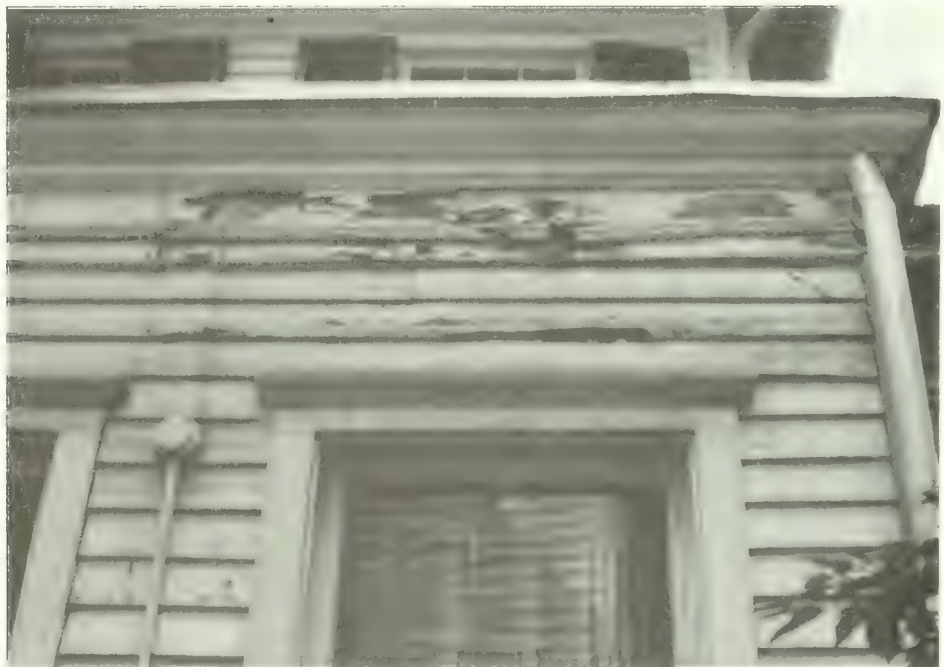
CP-35, Roof and flashing problems have caused severe deterioration at the exterior of the parlor stair and west porch. Engaged porch column, siding, trim are rotted. Porch rail is missing entirely.

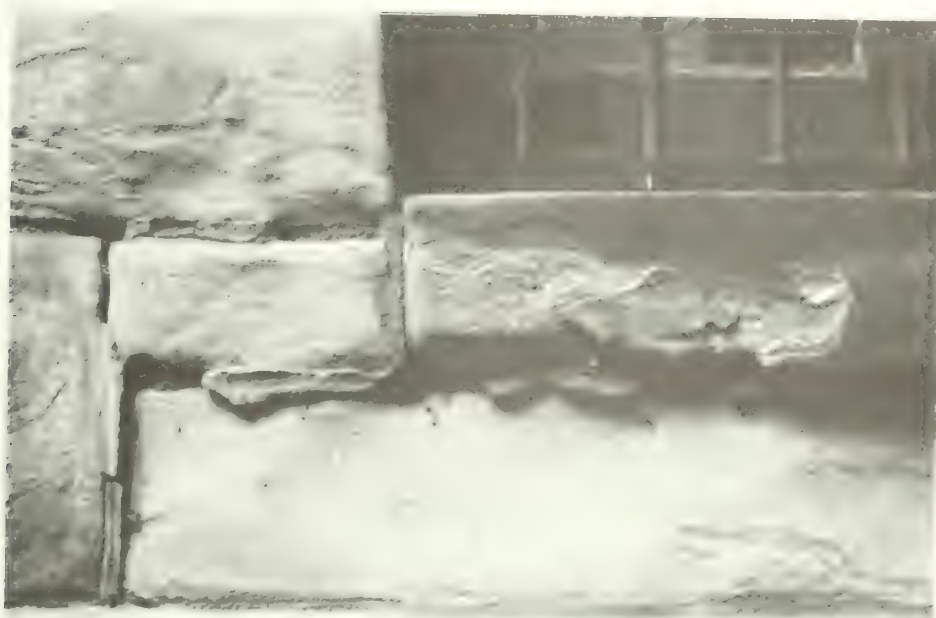
CP-37, Severe sandstone erosion at the memorial library first-floor window (W:114). This sill requires replacement.

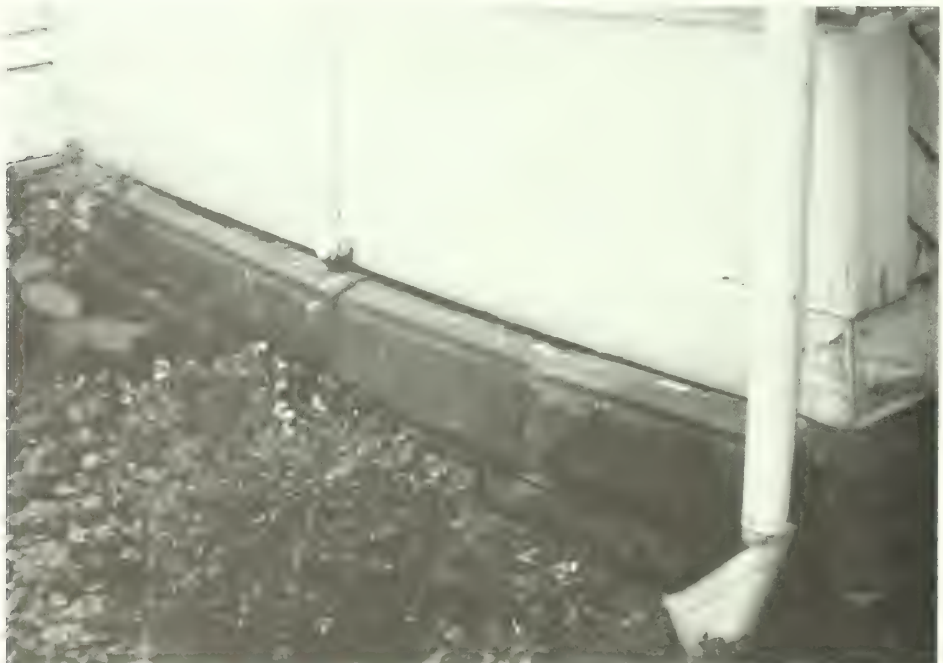
CP-39, An often blocked drain and separated stone veneer channeling into the foundation wall have caused deterioration of the brick masonry.

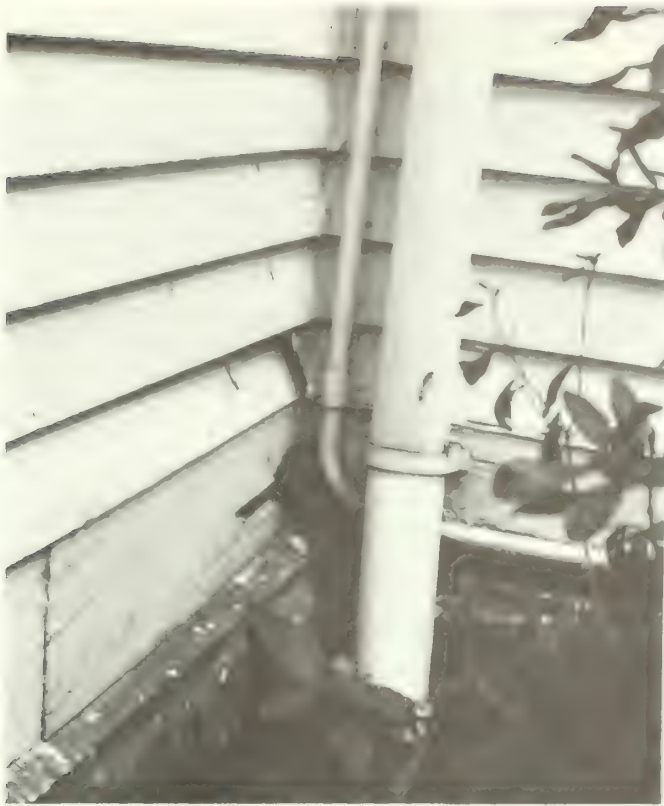
CP-40, Typical separation of sandstone foundation veneer channels moisture into the masonry.

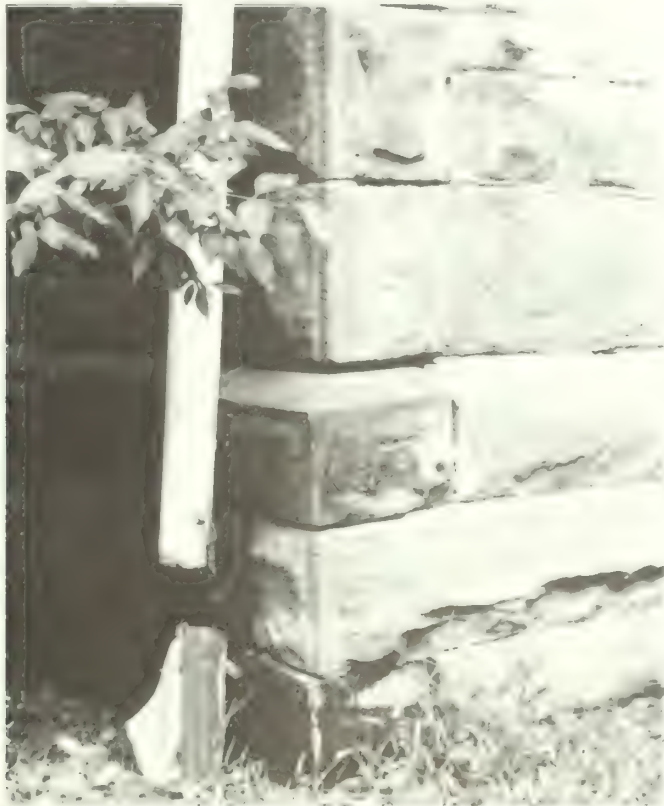
CP-41, Inside corner at 1885 kitchen. Water intrusion in the wall from the gutter above has caused severe deterioration from roof to foundation.

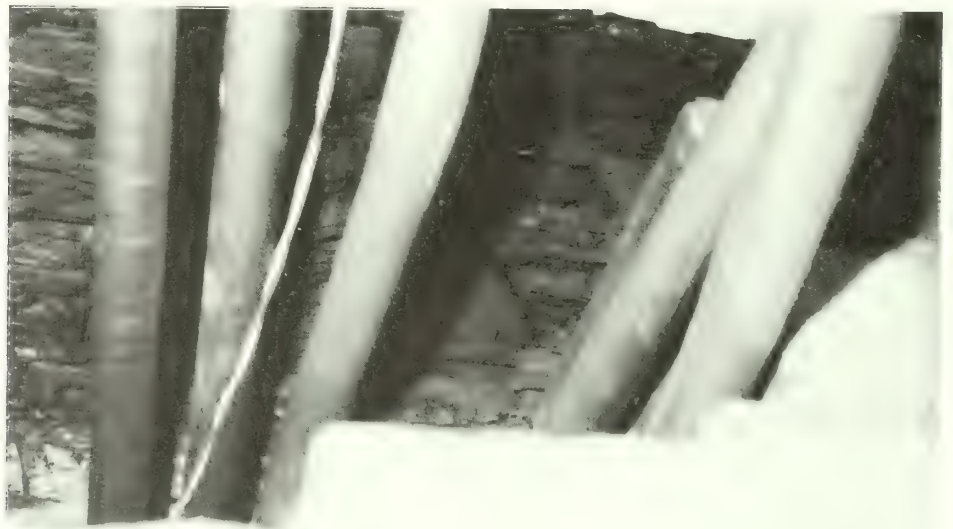
SP-24, Sill plate rot.

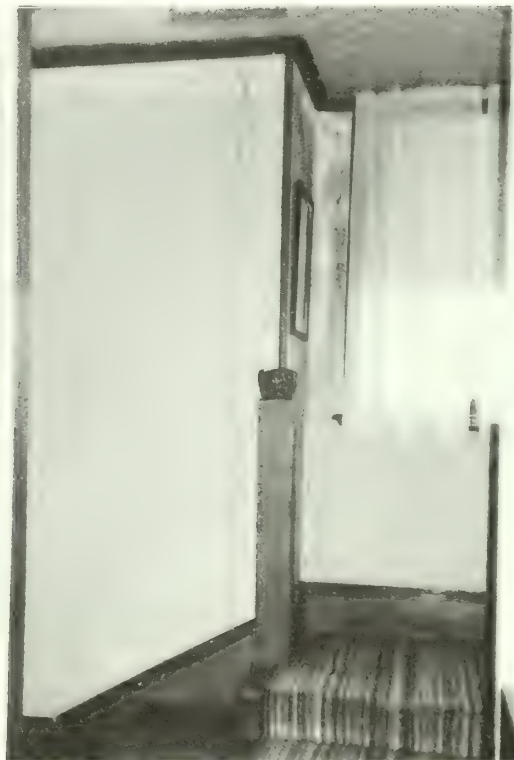
SP-28, Second-floor wall crack at the main stair.

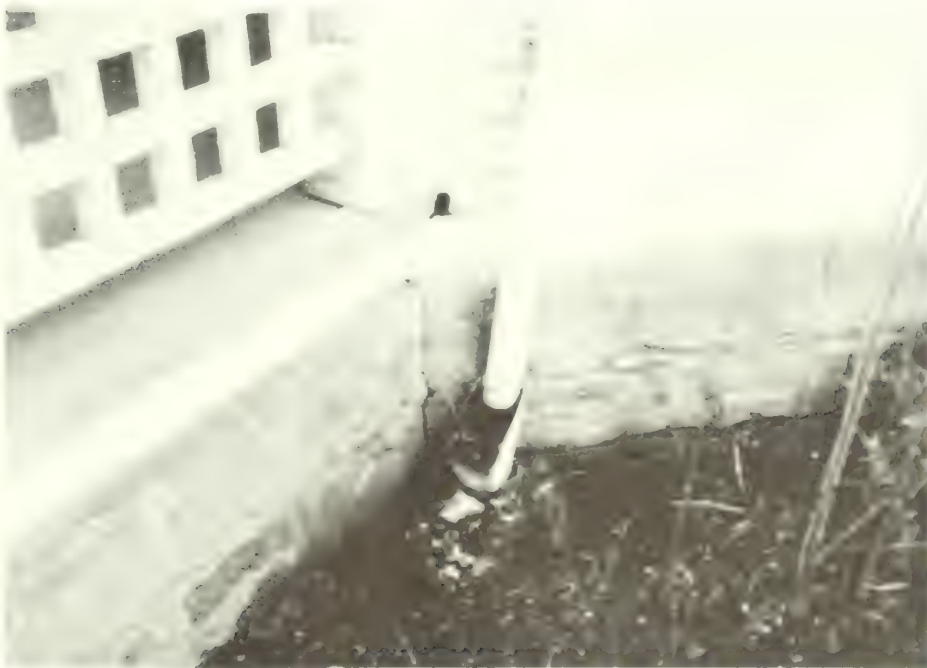
'42, Downspout drain overflowing.
